Thermographic Survey

DOMESTIC EXAMPLE REPORT

Survey Date 8th January 2016 Report Date 21st January 2016 Thermographer Mr. N.Gineer (ABBE Diploma QCF Level 4) Job No. 20000

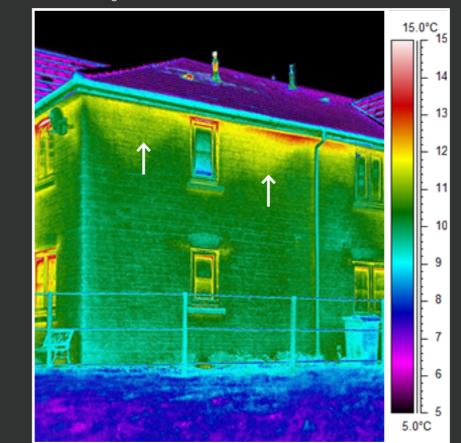
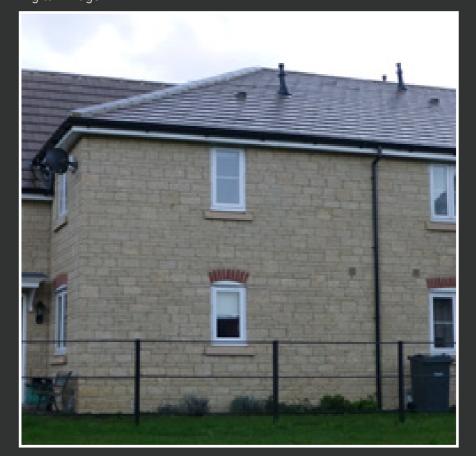
Even modern, new-build houses are not immune to missing insulation. The two white arrows in the thermal image point to areas where cavity wall insulation has compacted or slumped leading to some increased heat loss across the cavity wall. You cannot see any indication of this problem in the digital photo.

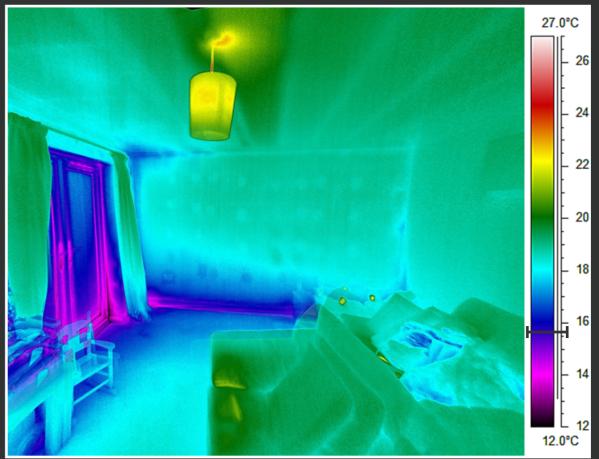
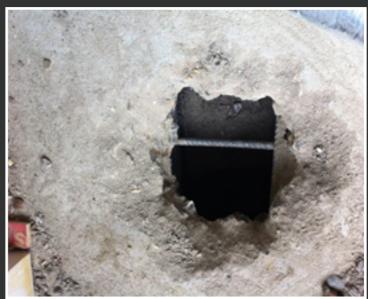
There are extensive colder areas in the image above – around the patio door, the floor the floor and the walls and also in the ceiling. A photograph taken during an investigation to determine the reason(s) for the cold floor showed that no insulation had been included - the design called for 300mm. Since the surface temperatures in many areas are at or below the thermal index temperature (15.8°C) there is a high risk of condensation and mould growth over time. Additionally, any occupant in this area is likely to feel a high degree of thermal discomfort - see below.

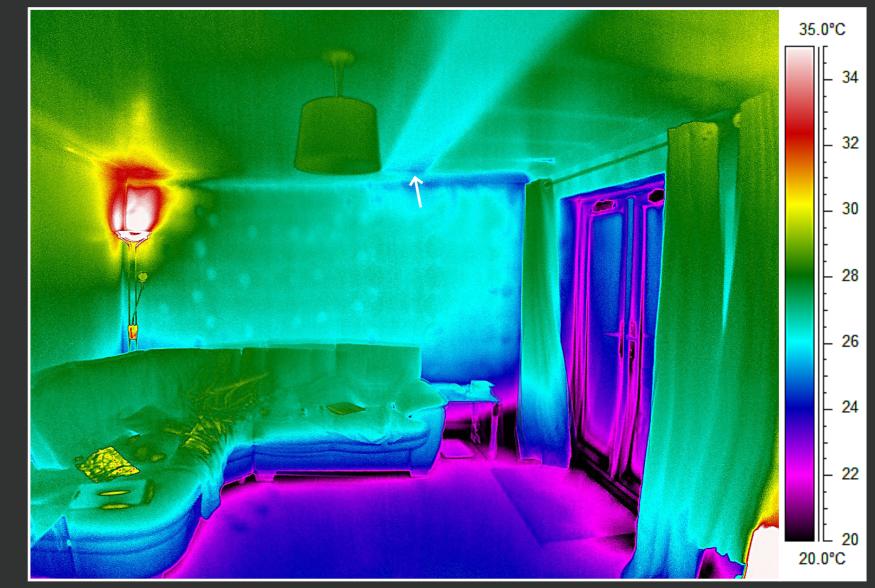
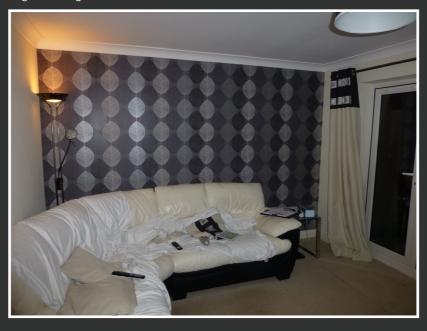
The owner of this house complained about feeling cold and would have to wear something on their feet to feel comfortable walking around the house in cold weather. This image shows a high temperature variation from ceiling to floor, but this variation is concentrated in the distance between the sofa and the floor. Since human beings feel uncomfortable if there is anything more than a 2°C - 3°C to temperature differences between their head and feet then this room is likely to cause severe thermal discomfort when sat on the sofa. The white arrow points to where a support beam above the ceiling is bypassing the insulation in the roof (a 'cold bridge') thereby reducing the effectiveness of the rest of insulation.

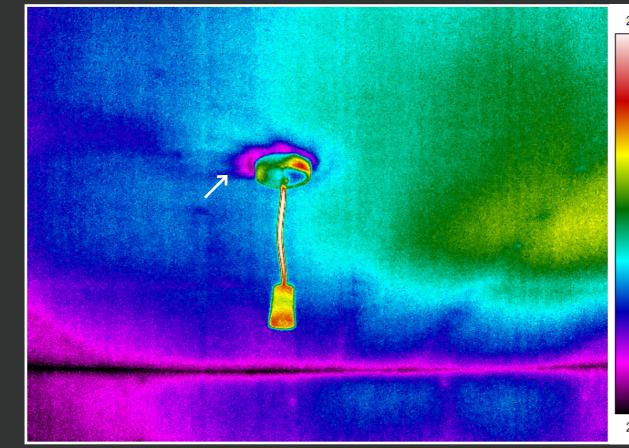
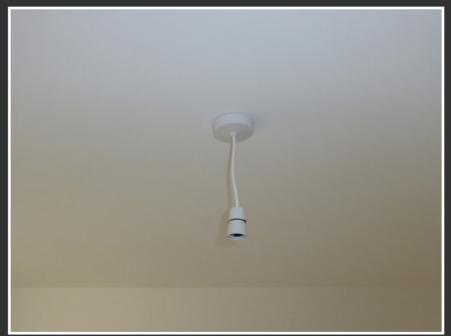
The white arrow points to some air leakage from the roof space past the lighting rose into the room. A house can lose substantial amounts of heat through excessive air infiltration - commonly called draughts. Draughts also reduce the level of thermal comfort experience by the occupants so excessive air infiltration should be minimised. However reducing the designed ventilation rates are likely to be counter-productive since the risk of condensation will increase rapidly as the ability to remove excess moisture from the air is reduced.

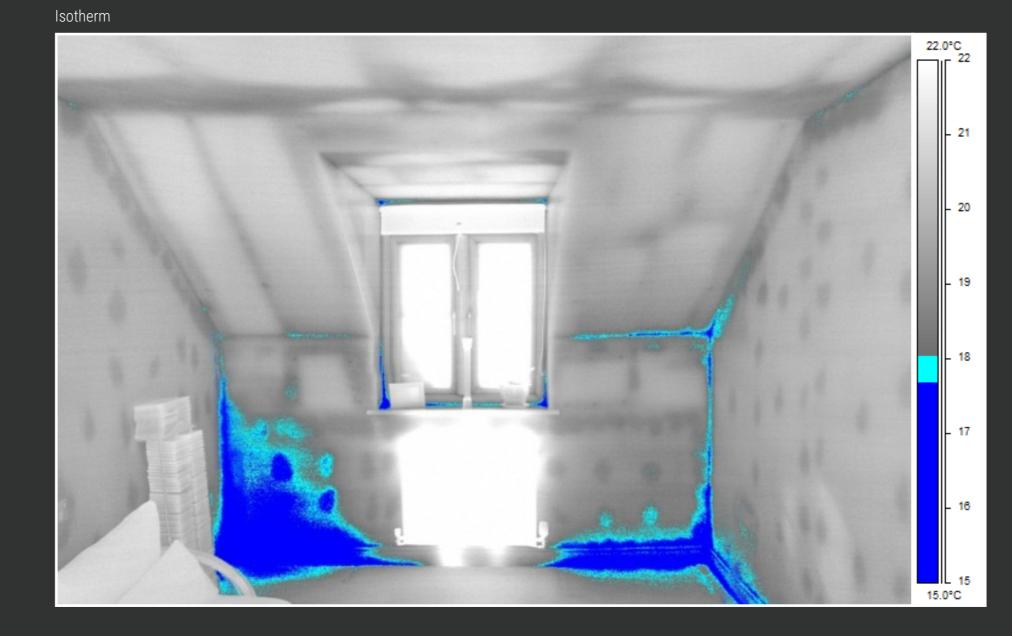
We introduced the concept of a Thermal Index temperature in an earlier slide. This is the temperature at which the risk of condensation and black mould growth increases significantly. The large image above has been processed from the small thermal image to show the areas with a high (dark blue) and lower (light blue) likelihood of condensation. A simpler way of showing which areas are at risk of condensation and mould growth is to mark the Thermal Index temperature with a bar on the temperature scale - as shown on page 7.
