Thermographic Survey

DOMESTIC EXAMPLE REPORT

Survey Date 8th January 2016 Report Date 21st January 2016 Thermographer Mr. N.Gineer (ABBE Diploma QCF Level 4) Job No. 20000

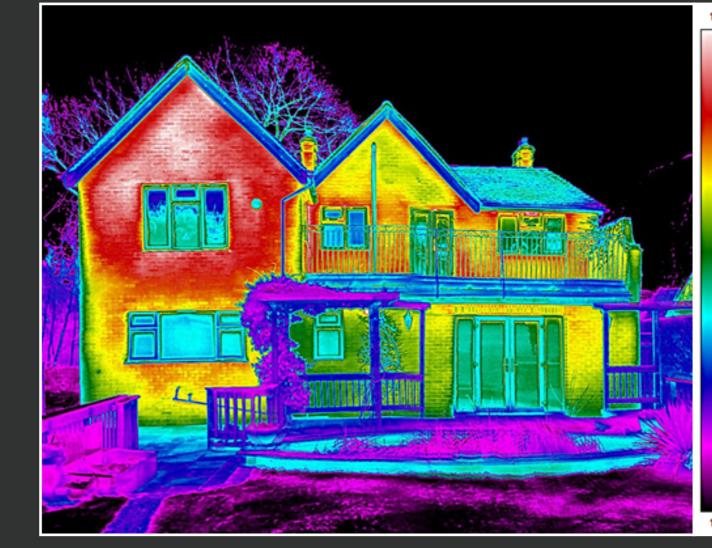
Thermal Image

Thermographic surveys enable you to to assess a buildings thermal performance without having to cover it with temperature probes - or dismantling it. Information contained in a thermal image like the one above can be used to identify the location and severity of any problems. However, thermographers need to be careful in their analysis since the 'hot' area in the upper left part of the house has been caused by heat from the sun - called 'solar gain'. The digital image explains why the other South-facing aspects of the house haven't been so badly affected - they have been painted white (which reflects the sun) or are shaded by the balcony. To prevent problems from solar heateing thermographic surveys should be carried out at night.

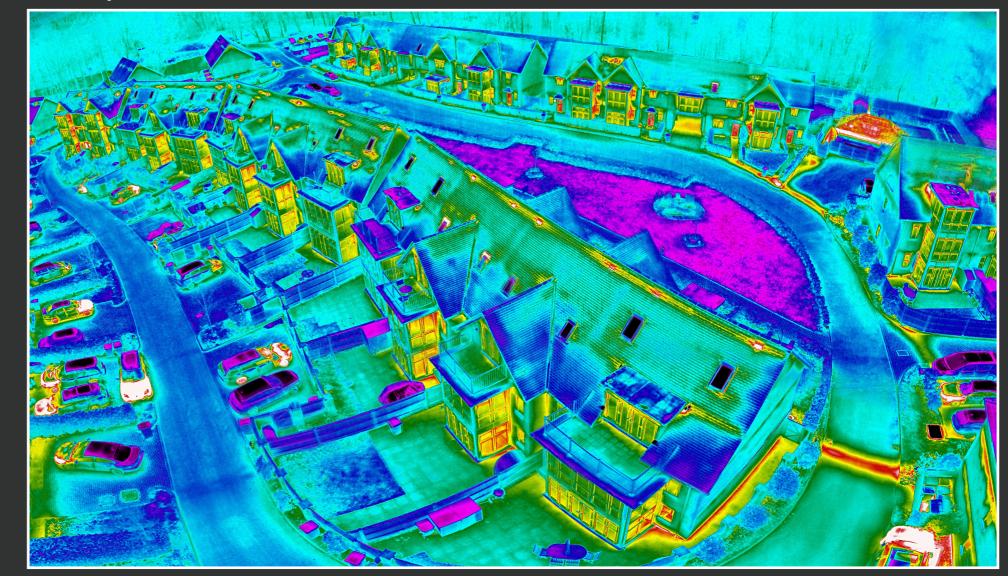
Thermal Image

Our aerial surveys allow us to inspect buildings from new perspectives. This enables us to gather data and information that would otherwise be inaccessible without scaffolding or a mast.
